DESIGN OF A PILE REINFORCEMENT OF A MOTORWAY SLOPE IN SOFT COHESIVE SOILS

Guillermo Ibarra, Erik Chávez (*)
Manuel de Cabo, José M Galera (**)

(*) SUBTERRA Ingeniería Ltda. Alfredo Barros Errázuriz 1960, Santiago, Chile
(**) SUBTERRA Ingeniería SL. Vallehermoso 18, Madrid, Spain

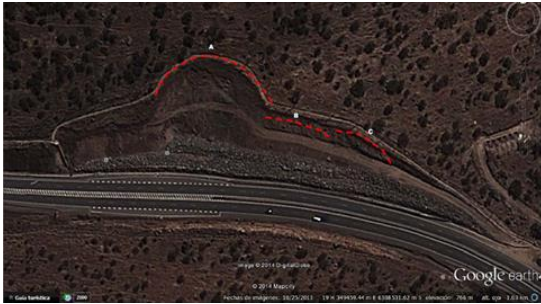
Since the finalization of the motorway construction, a succession of minor events was recorded between Km 5+240 and 5+140, from December 2006 to September 2008. For this reason, in the Northern part of the slope (right hand side in Figure 1), between Km 5+300 y 5+000, it was necessary to modify the inclination of the slope (down to 50°) and to reinforce the toe of the slope with a rockfill wall. The result of these stabilization measures can be observed in **Figure 1**.

Figure 1. General view of the stabilization measures constructed in 2009 (laying down of the slope inclination and rockfill wall reinforcement)

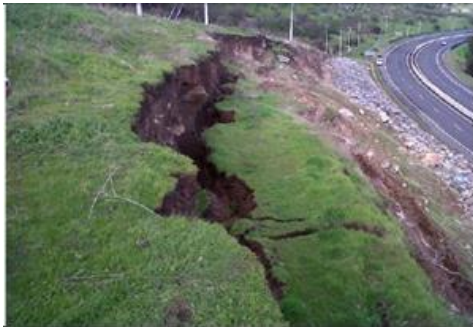
Five years later and in winter time, August 2013, some minor failures of the slope took place, making necessary to carry out partial re-excavation of the slope, in its Southern part, between 5+180 to 5+020 (left hand side of Figure 1). The problems continued and for this reason at the beginning of 2014 it was decided to make a global reparation of the slope in its section from 5+200 to 5+000.

Figure 2. Slope failure registered in August 2013

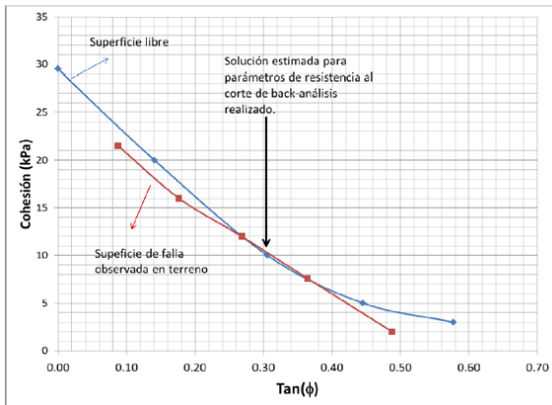
Figure 3 shows the result of these analyses. In blue colour the first stage is represented, while the second stage corresponding to the observed site failure has been represented in red colour.

The intersection of both curves, give us the values of the shear strength of the soil. In this case the following values are obtained:

- Cohesion: 10 kPa
- Angle of friction: 17°

Figure 3. Sensitivity analysis cohesion/angle of friction to obtain FS=1

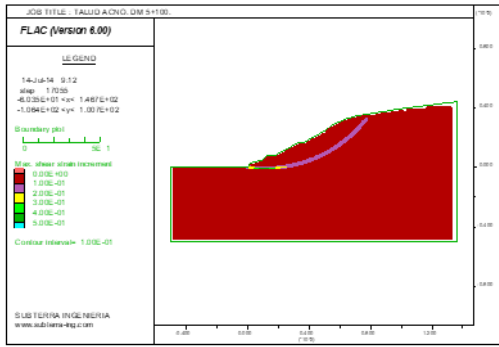
Figure 5. Back analysis. Shear strain distribution at the slope failure

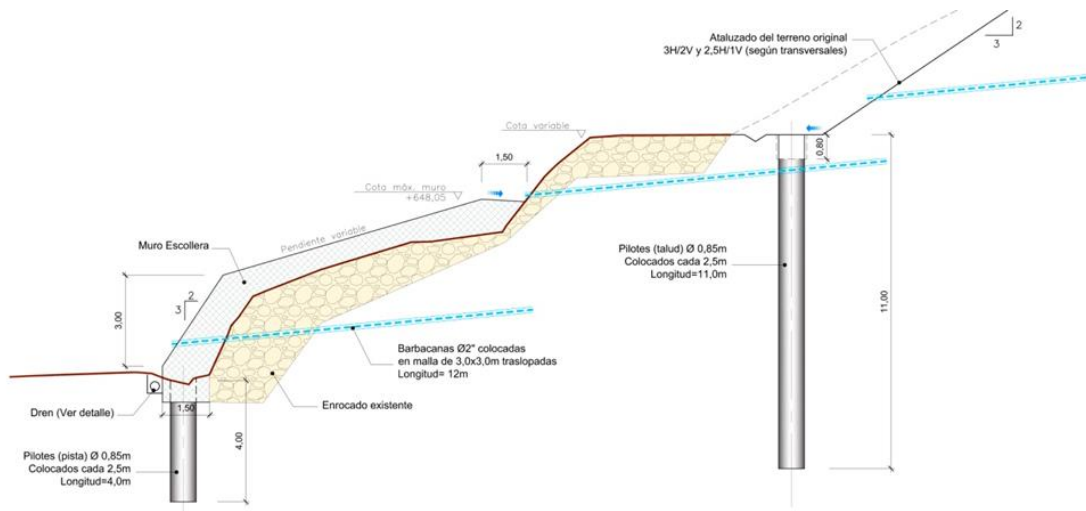
Figure 6. Slope reinforcement measures designed

The slope reinforcement consists in a combination of draining measures and a pile-reinforcement. In detail the measures proposed were:

- Three rows of Californian drainages, in order to reduce pore pressure at the slope face
- Down load of the slope head, respecting the eminent domain as well as two existing electric poles
- Two retaining walls with reinforced piles (\varnothing 85 cm; 2.5 m spacing). A first one located at slope toe ($l=4$ m) and a second located at the inner slope berm ($l=11$ m)
- Concreted rock fill wall at the foot of the slope

Figure 6 shows a section of the slope with all the reinforcements.

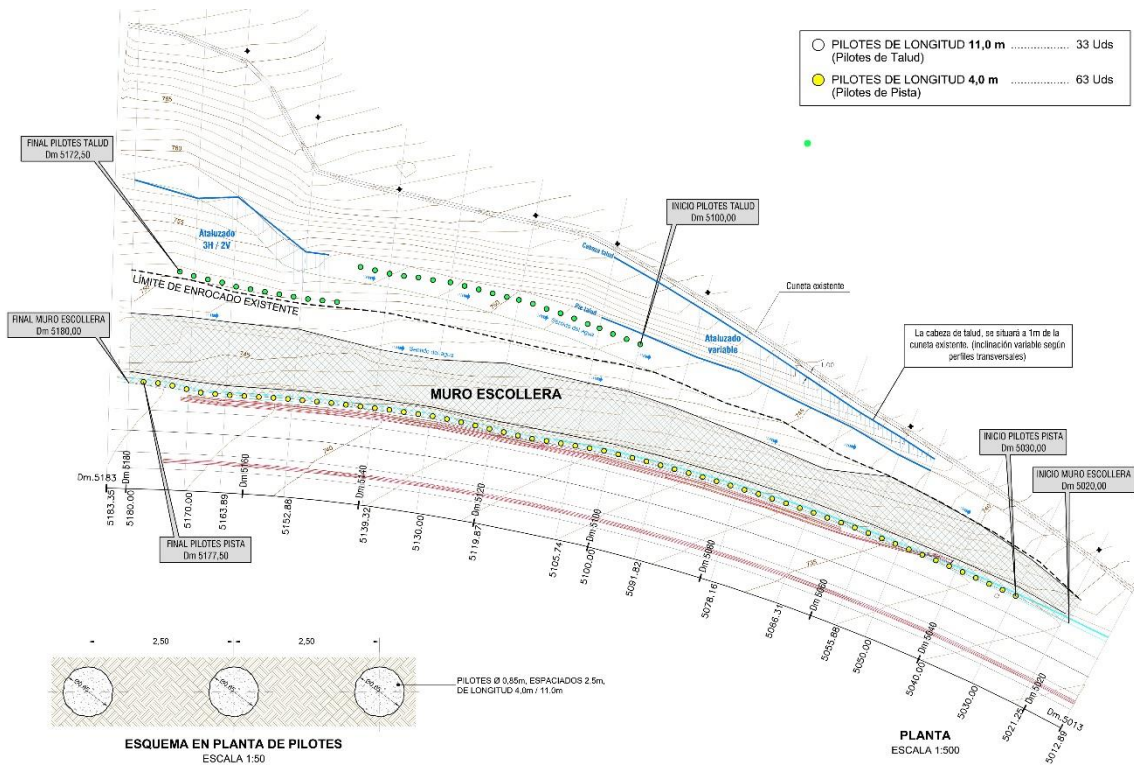
Figure 7. Plan view of the slope reinforcement measures

In **Figure 7** these slope reinforcement measure are shown in a plan view of the motorway.

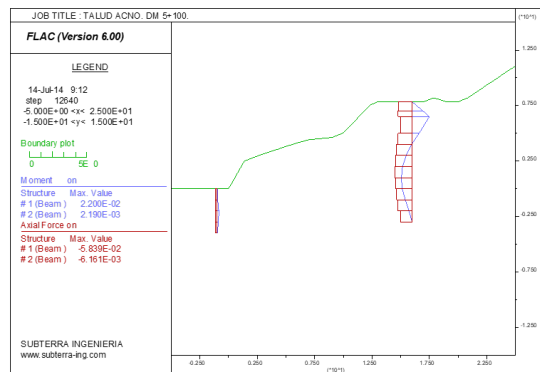
In **Figure 9** the results of the calculation are included. As it can be observed the maximum moment is 2.2 mt/m while the maximum axial force at the structure is 5.8 t/m.

The resulting global Factor of Safety is 1.18, while this value decreases to 1.1 if the seismic action of 0.2g, according to the Chilean seismic regulations, is considered.

Figure 9. Moments and axial forces at the retaining wall
