ROCKBURST MITIGATION EXPERIENCES ON UNDERGROUND PROJECTS IN THE ANDES. CHEVES HYDROPOWER PROJECT, PERU.

Key words: tunnel, cavern, depth, rock support, rockburst.

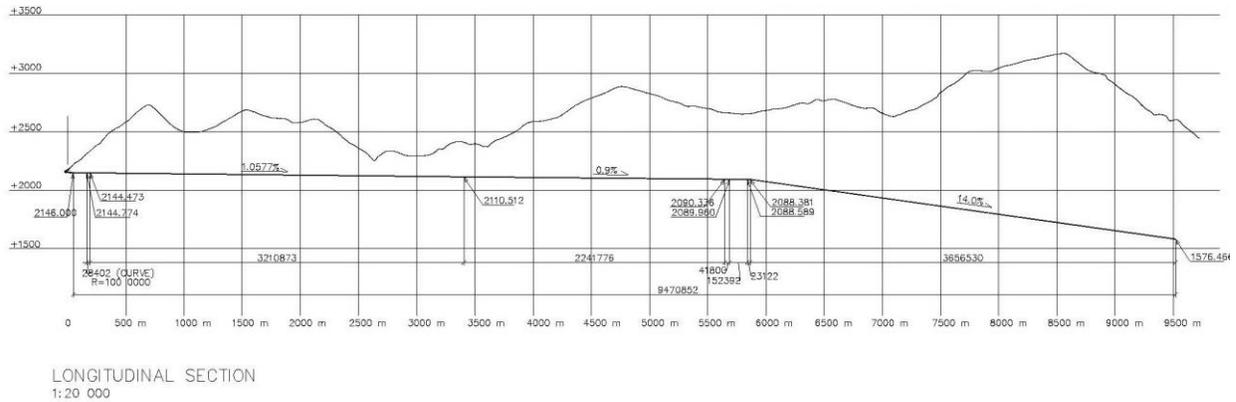
Figure 1 shows a longitudinal section of the project showing all the already described components of the hydropower project.

Figure 1: Longitudinal section of Cheves Hydropower project

As it can be observed, there is a section in the Headrace tunnel, linked to the steepest stretch where the overburden is systematically above 1.000 m, being the maximum around 1.500 m. Basically, the dynamic or stresses related events took place in that tunnel section as well as in the cavern complex at the Powerhouse area.

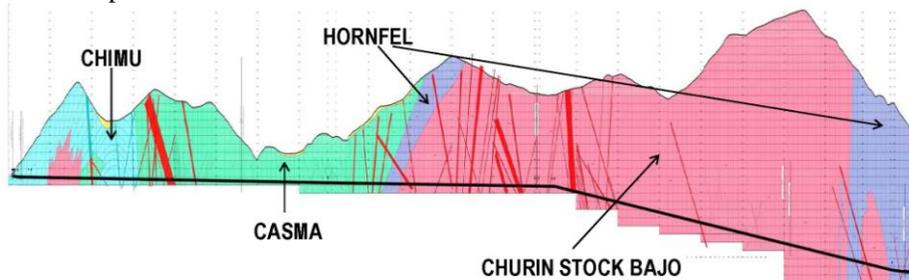
Figure 2 shows a longitudinal section of the project showing all the described geological groups.

Figure 2: Geological longitudinal section of the project

The headrace tunnel and powerhouse area, in which the dynamic events were recorded, have been excavated in hard rock: granites and hornfels.

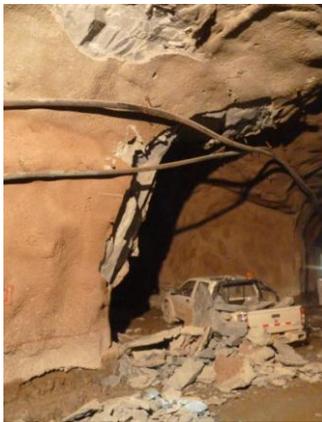
Figures 3 and 4 show an example of two rockbursts that happened in Cheves project, the first one behind the excavation face, near the Powerhouse cavern, and the second one at the excavation face during the construction of the Headrace tunnel.

Figure 3: Rockburst in a drift near the Powerhouse Complex

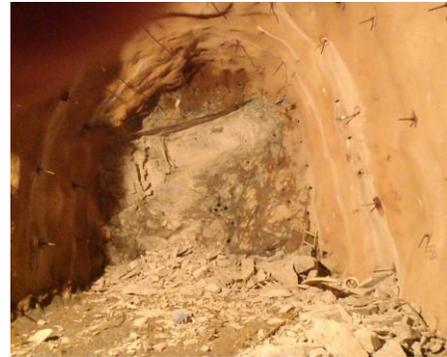
Figure 4: Rockburst at the face excavation in the headrace tunnel

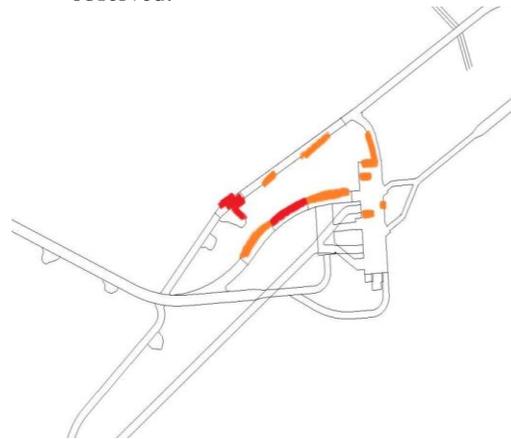
- Induced stresses:** the excavation of multiple faces at the same time, as well as the existence of close excavations played a key role on the probability of rockburst events. This issue had a significant impact on the powerhouse area due to the great number of close drifts, as can be observed in the Figure 6, in which the rockburst events have been highlighted in orange (medium intensity) and red (high intensity).

Figure 6: Rockbursts record in the Powerhouse area

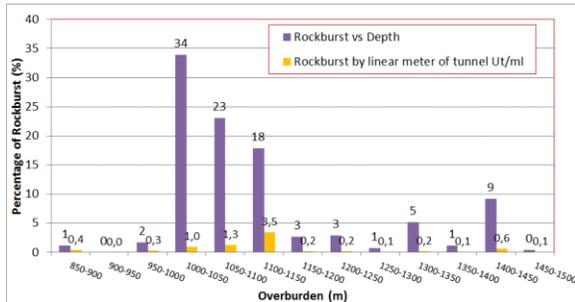
Figure 7 compares the rockburst intensity and the overburden. It's noticeable that 75% of the events took place between 1,000 to 1,150 m of overburden. In this stretch the average was about more than 1.0 events per linear meter of tunnel, event between 1,100 and 1,150 m of overburden took place a ratio of 3.5 events per linear meter of tunnel.

Figure 7: Overburden vs. rockburst and event by meter.

Surely this distribution is strongly conditioned by others factors, in particular by the lithology.

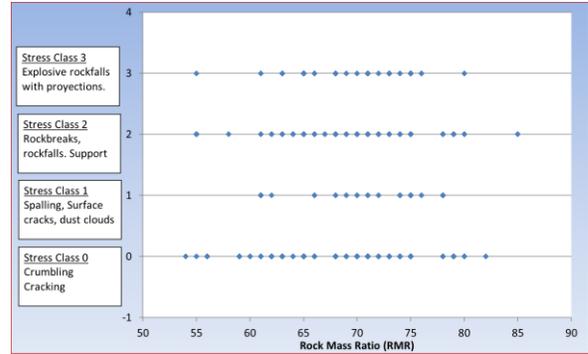
The rock mass rating (RMR) and the rockburst intensity are analyzed in Figure 8. Most of the severe events (stress class 3) belong to rock class II and I, i.e. when the RMR is higher than 61.

Figure 8: Rockburst intensity vs. RMR index

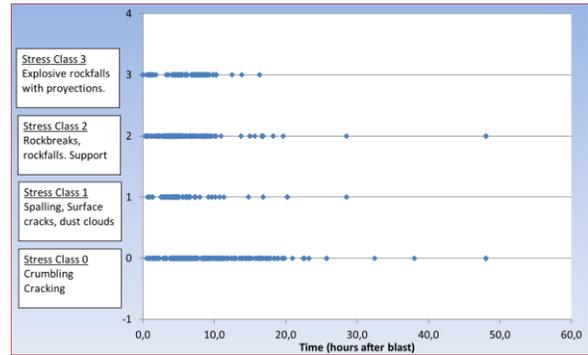
Another interesting analysis is the relation between the rockburst intensity and the time after blasting (Figure 9). It must be highlighted how the most severe events are located in the first ten hours after the blasting was carried out.

Figure 9: Rockburst intensity vs. time after blasting

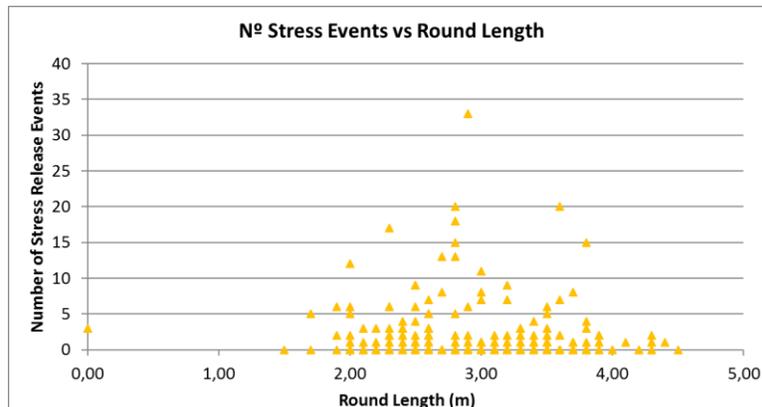
Finally, the relation between the blasting length and the number of events is analyzed in Figure 10. It's worth mentioning an increase in the number of rockbursts in parallel to the increase of the blasting length.

It can be observed that there is no clear relation between rockburst occurrence and the blasting length.

Figure 10: Blasting length vs. number of events

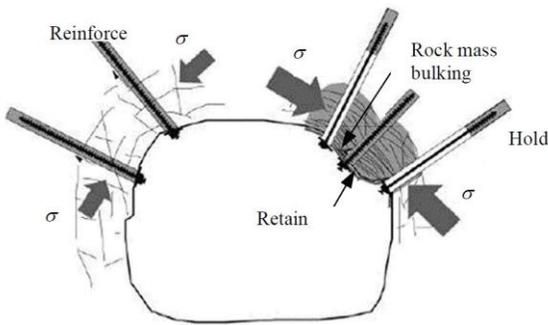
Rock supports will inevitably be damaged after the rockburst event, requiring repair works and reinforcements, but a proper design must provide a flexible support, enough to resist the dynamic loads set by the rockburst, and therefore comply with the following aims: reinforce, retain (rock mass bulking) and hold, avoiding violent rock projections. Figure 11 shows this concept.

Figure 11: Requirements for an adequate support for dynamic events (Kaiser and Cai, 2012).

The support measures described in this paper were effective during the construction period. The support consisted in an integrated system that permits to reinforce the rock mass to strengthen it, (2) retain broken rock to prevent fractured block failure, and (3) hold fractured blocks and securely tie back the retaining element(s) to stable ground.

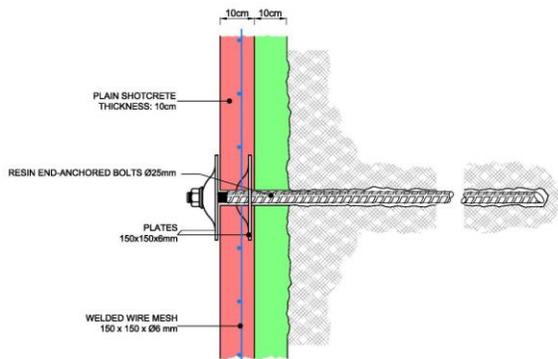
In the particular case of Cheves hydropower project, the rocksupport was specifically designed to cope with the rockburst events and high stress levels, consisting of long grouted rock bolts and double layer of fibre reinforced shotcrete with a welded wire mesh embedded in the shotcrete, which provides the required ductility against the dynamic loads.

It was designed a high performance shotcrete with an UCS between 40 and 50 MPa and 6-7 kg/m³ of plastic fibers or alternatively 40 kg/m³ of steel fibers, obtaining more than 1.400 J in the panel test, according to the EFNARC requirements. Figure 12 shows this concept of a double-layered support.

Figure 12: Rocksupport designed for high stress levels.

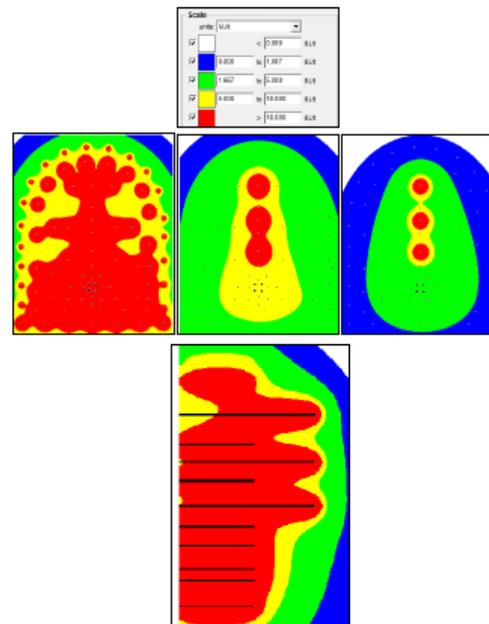
- Preconditioning blasting ahead the excavation face, performed before the regular blasting, with the aim of reducing the rock mass quality by creating new cracks (Figure 13).

Figure 13: Energy distribution in a preconditioning blasting with 3 holes of 51 mm diameter charged with Slurxex.

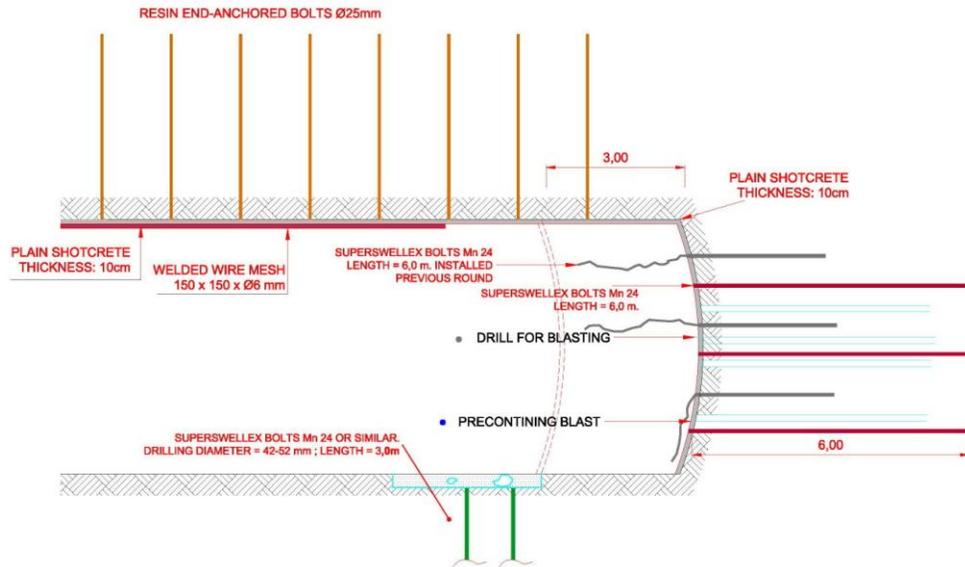
The following figure shows a scheme of the temporary rock support installed at the face and the preconditioning blasting layout:

Figure 14: Combination of protection and prevention measures at the excavation face in rockburst prone conditions.

- Mechanical scaling and reinforced machinery in order to protect the workforce at the tunnel face.
- Apply a “sacrificial” layer of fibre reinforced shotcrete at the face and install temporary swellex rockbolts also at the face, with the aim of avoiding rock ejections from the face.
- Install temporary swellex rockbolts in the cross section just after shotcreting the first layer, in order to stabilize the section and ensure the safety of the workforce during the process of finishing the installation of the remaining rock support.
