Construction of portals in difficult conditions in the Andes, Peru

M. Boisán, M. de Cabo & C. Quiroga

Subterra Ingeniería, Spain

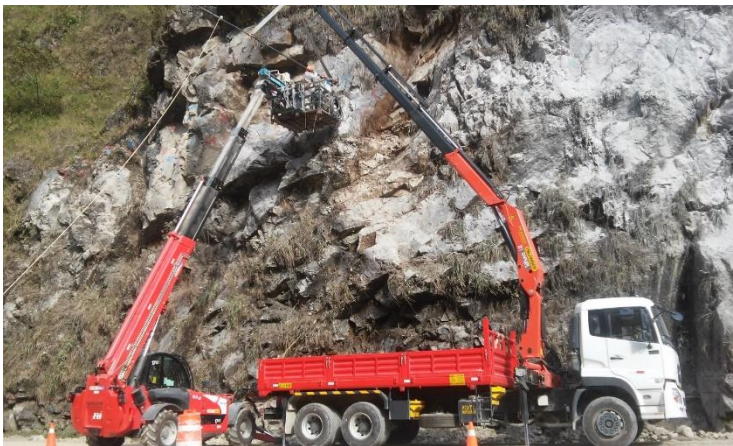
Photography 1. Slope pre-reinforcement.

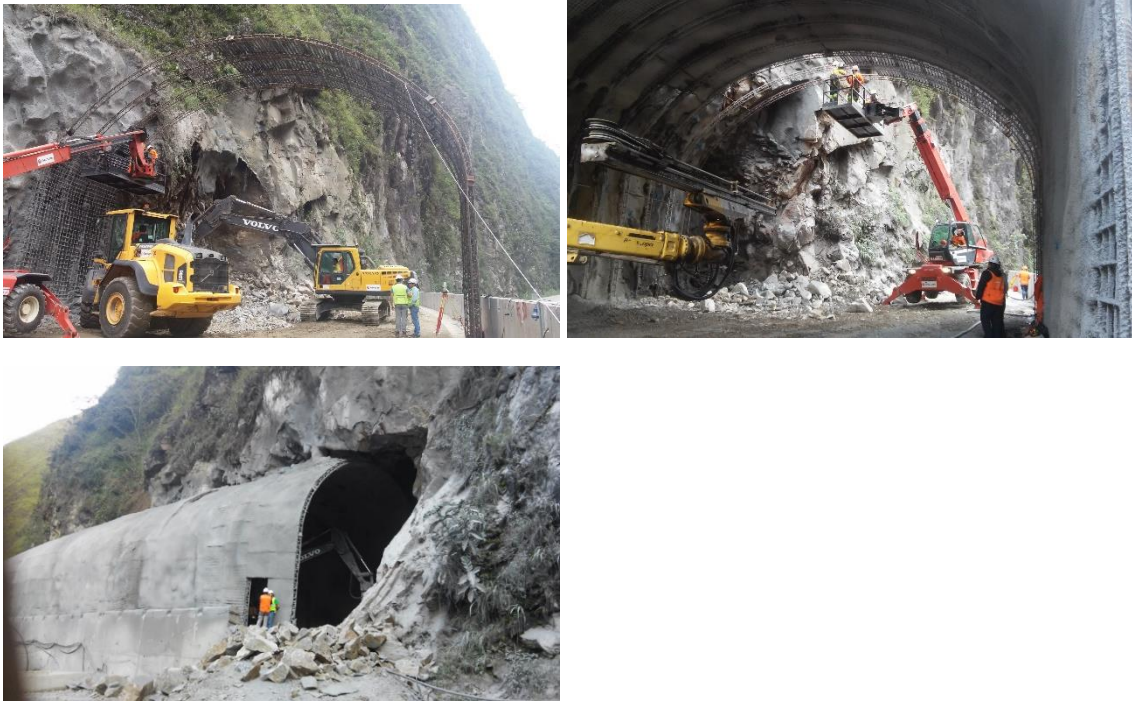
Photography 2. Part-tunnel and structure construction.

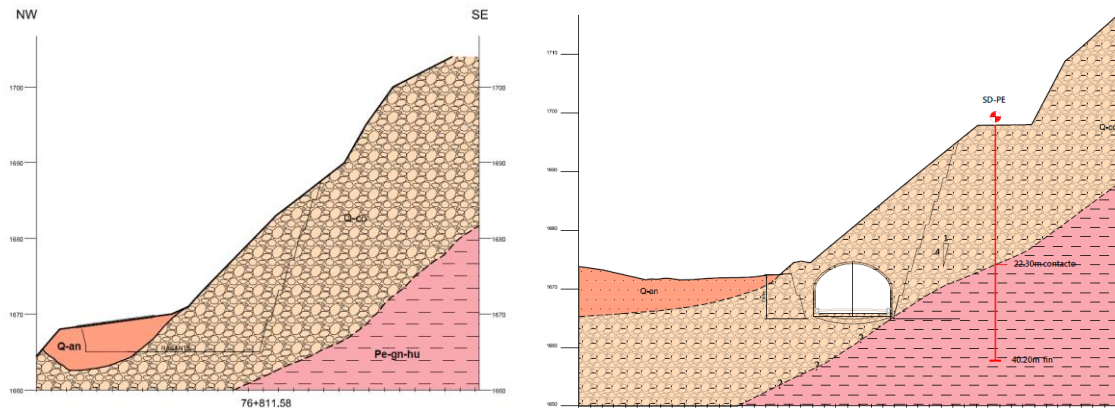
Figure 7. Geological sections in entrance portal.

In order to define soil properties and the rock contact, three pits and a 40 m length borehole was carried out. In addition, and based on the complex of the portal, an inclinometer was installed in the borehole in order to control the stability during the portal excavation.

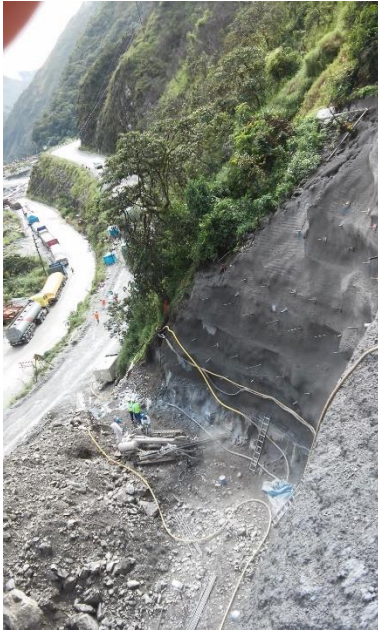
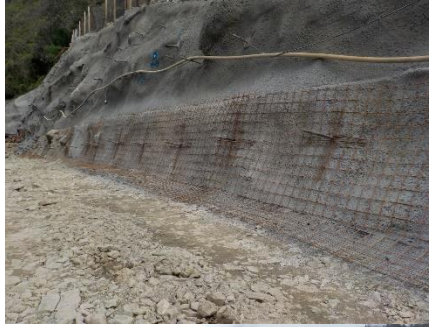
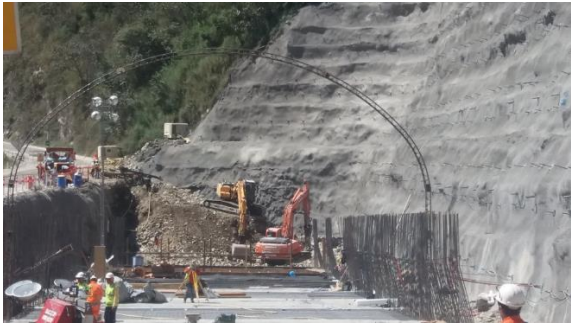
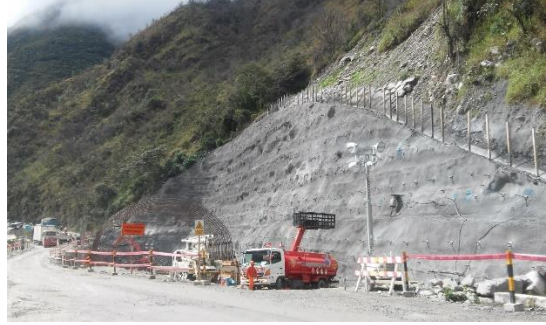
Photography 3. View of the excavations.

The main excavation and reinforcement of entrance portal started on February 2016 and ended on June 2016, having placed 808 self-drilling bolts and 135 drains.
